QUINAULT
INDIAN
NATION

REACH ASSESSMENT DESCRIPTIONS

Quinault Indian Reservation Reach Assessments | William E. Schlosser

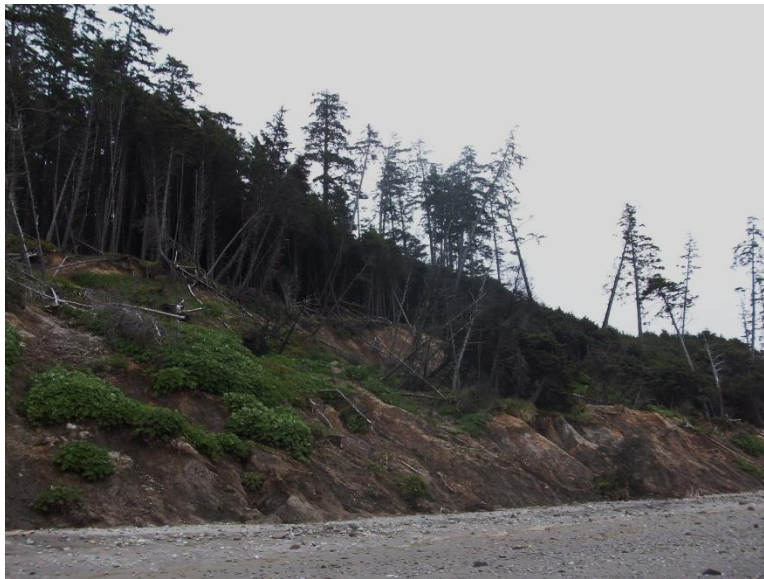
Figure 9. Drunken Forests of the Quinault Formation near Hogsback.

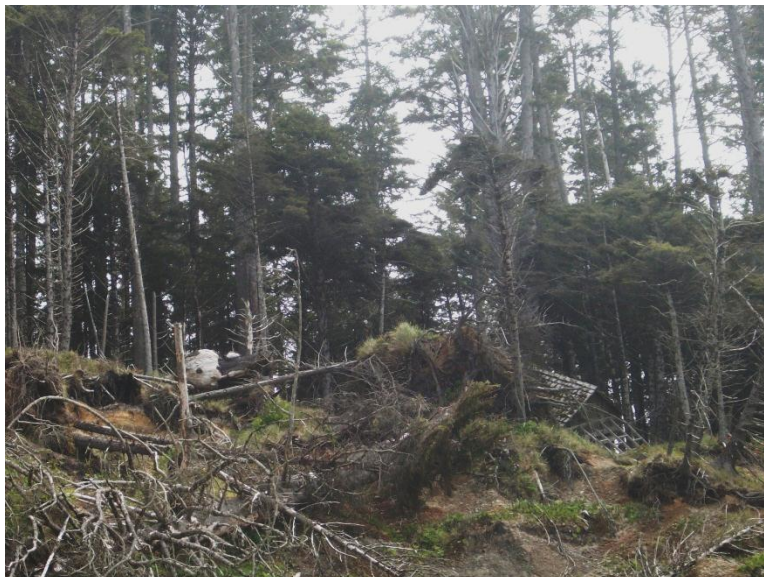
because of the geologically 'brittle' reaction of this formation to compaction and vibration. It is not generally viewed as a desired foundation material for roads, heavy structures, or commercial uses. Several of the small 'cabin like' structures placed along the coastline north of the Tunnel Island area have slid down the cliff as the addition of water, compaction, and vegetation control, combined with the wave-cut platform avulsion have weakened the cliff face to release the burden of the structure to the shoreline (Figure 10). A similar site response to construction on Quinault Formation bedrock is seen near Cape Elizabeth where a WWII Artillery Bunker Site was erected (Section 3.6.1), resulting in substantial site failures.

Figure 10. Failed cabin along the shoreline cliff located north of Tunnel Island.

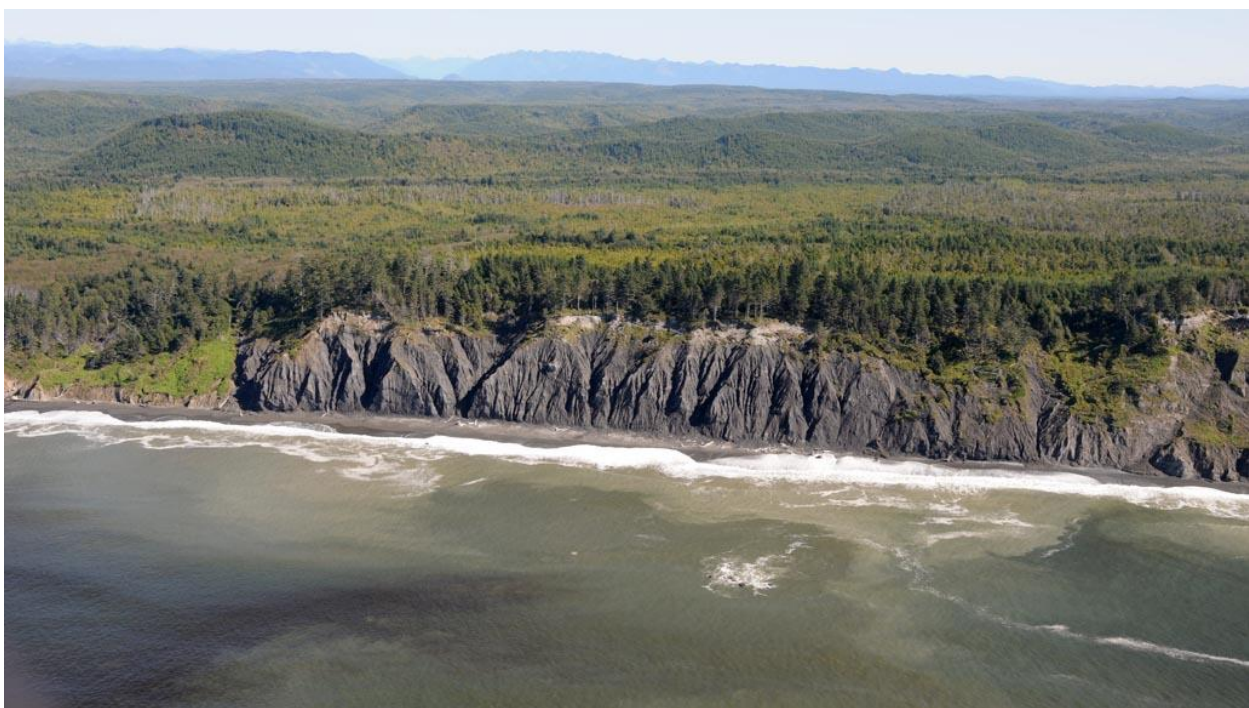
As an engineering substrate, the Hoh rock assemblage and the tectonic mélangé (Figure 12) are very unstable. The tectonic mélangé is the substrate under SR 109 at Swede Hill. This stretch of the road has been documented for over 100 years as a problematic stretch of the route failing from compression, vibration, and water movement across the compressed materials. Efforts to repave, riprap, place culverts, and otherwise reroute this stretch of the highway, have met with failure. This geologic foundation compacts irregularly and builds up pore water pressure from the compaction within the soil complex. When pressures exceed the holding capacity of the soil, it ruptures water to release the burden. When possible, construction should not be placed over this substrate.

Figure 12. Tectonic Mélangé epitomized by the Duck Creek Diapir (Workman 2012).

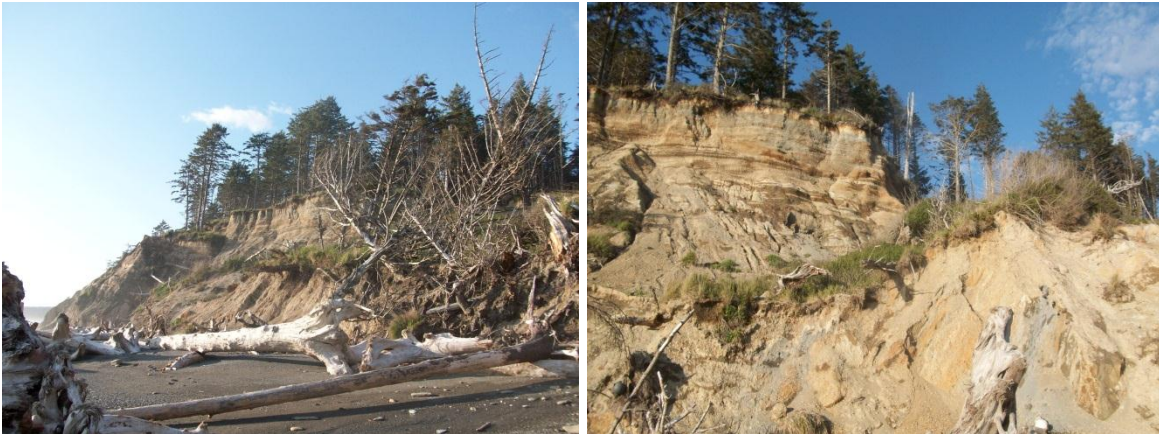
Figure 33. Site failure and the drunken forest of the Quinault Formation between Point Grenville and Taholah.
