QUINAULT
INDIAN
NATION

REACH ASSESSMENT DESCRIPTIONS

Quinault Indian Reservation Reach Assessments | William E. Schlosser

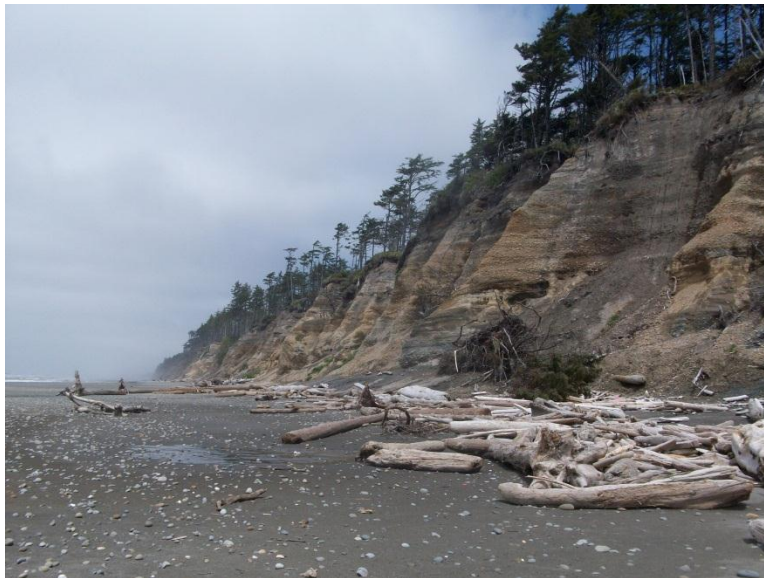
The natural accumulation of large woody organic materials along the Quinault marine shorelines serves a substantial role of protecting shorelines from avulsion during strong winter storms. The collection of these log materials is most prevalent south of the Quinault River entrance to the ocean and north of the Queets River entrance. Other locations benefit from smaller collections of the large woody organic materials associated with river estuaries. In other locations the materials are less dense and appear as a response to localized cliff face avulsions (Figure 2).

Figure 2. Large woody organic materials accumulated along the shorelines north of Whale Creek, with avulsed tree stems recruited at the center of the photograph.

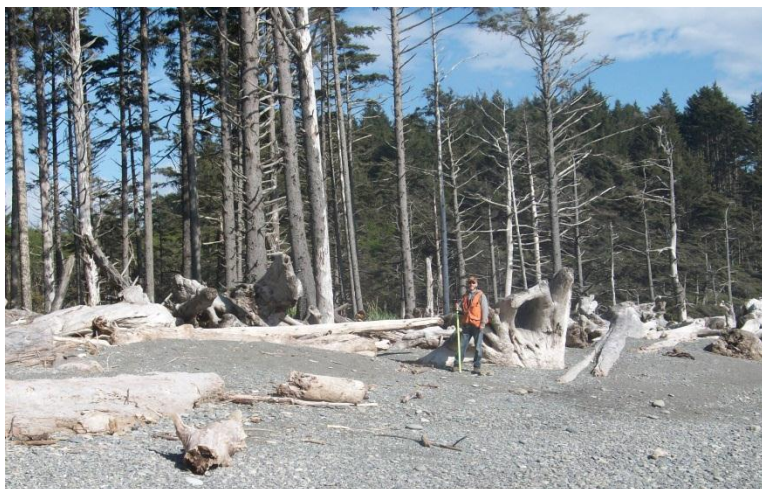
While the benefits of the large woody organic materials are seen mostly on the surface of the shorelines, in many places the tree stems are present in subsurface layers beneath sand and conglomerate materials for significant depths (Figure 4). As the seasonal rearrangement of shoreline deposits is made, the subsurface large woody organic materials serve to retain structure during advancement or retreat of the tidal zone.

Figure 4. Partially buried tree stems along the shorelines near Taholah.

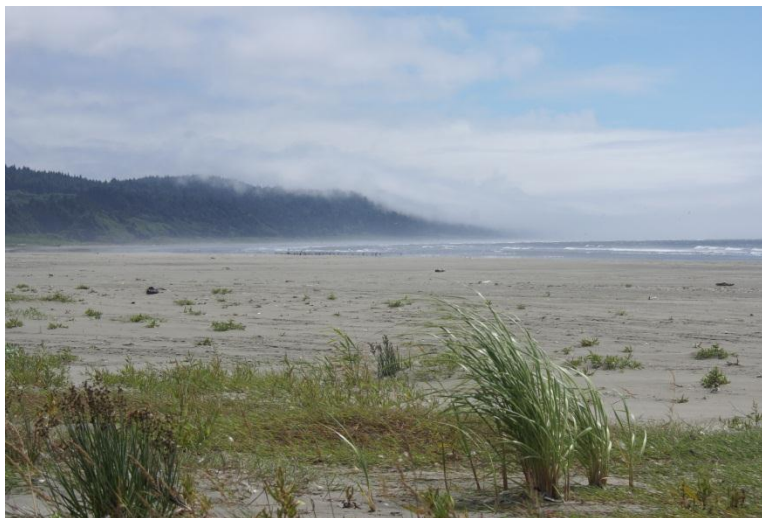
Figure 5. Grenville Bay near Wreck Creek showing CRLC sands.

The CRLC sands along the Quinault marine coastlines respond to both the rate of contribution of new sands from the Columbia River, and to the geologic substrate under the sandy shorelines. In many places the sands are over 100 meters deep, but at this northern terminus of the CRLC extent, the sand layers are relatively thin, measuring in places only a few meters or less in depth (e.g., near Wreck Creek).

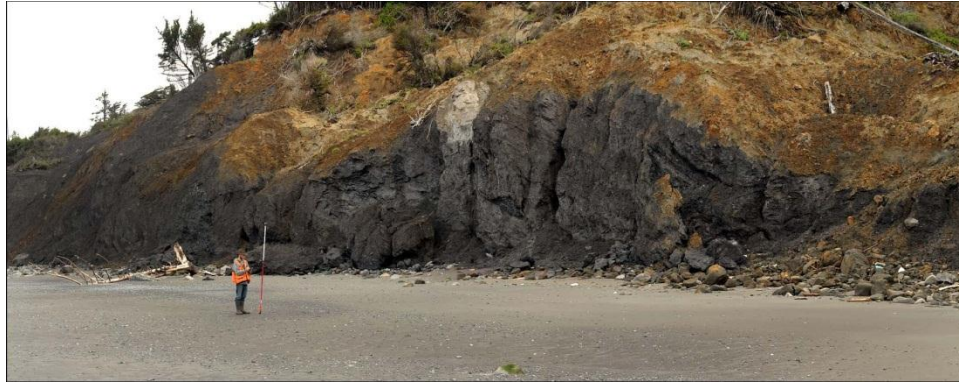
The Hoh Assemblage is a coherent sequence of sandstone and siltstone that has been tilted, broken by tectonic forces, and eroded by rain patterns (Figure 11). Generally the Hoh rock assemblage is seen as layers that have been tilted or broken, but the original formation is generally seen as a horizontal deposition of layers. Intermixed with this assemblage is the "tectonic *mélange*." Often, this *mélange* has been forced through semi-porous materials along fault lines where the partially dissolved and viscous substance was reformed and squeezed into places where the pressures were lower.

Figure 11. Hoh Assemblage and piercement structures near Hogsback (Workman 2012).

As an engineering substrate, the Hoh rock assemblage and the tectonic mélangé (Figure 12) are very unstable. The tectonic mélangé is the substrate under SR 109 at Swede Hill. This stretch of the road has been documented for over 100 years as a problematic stretch of the route failing from compression, vibration, and water movement across the compressed materials. Efforts to repave, riprap, place culverts, and otherwise reroute this stretch of the highway, have met with failure. This geologic foundation compacts irregularly and builds up pore water pressure from the compaction within the soil complex. When pressures exceed the holding capacity of the soil, it ruptures water to release the burden. When possible, construction should not be placed over this substrate.

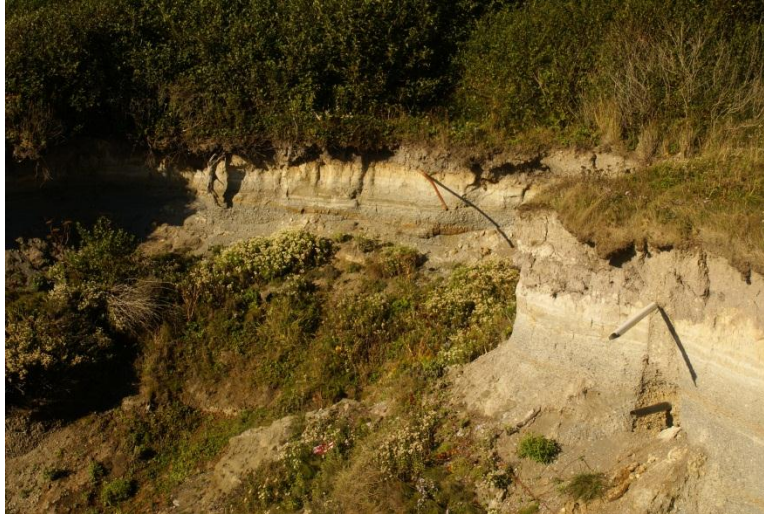
Figure 13. Eocene Sedimentary Rocks of Point Grenville where the US Coast Guard Station water lines are now exposed to show where they once were buried underground.

Maps 16 and 17 show avulsion rates from the original 1939 markings compared with 2012 slope failures surrounding this road’s original placement. Map 17 specifically shows the bedrock outcrops the road traversed. A quick comparison of these bedrock formations in relation to the road’s placement shows very little impact where the road crossed volcanic basalt rocks. Where the road crossed Late Eocene Sedimentary rocks and Hoh Assemblage rocks the cliff edge shows evidence of evulsion (Figure 13). The rate of cliff face loss exceeds 600’ (horizontal) where the Taholah road crossed it.

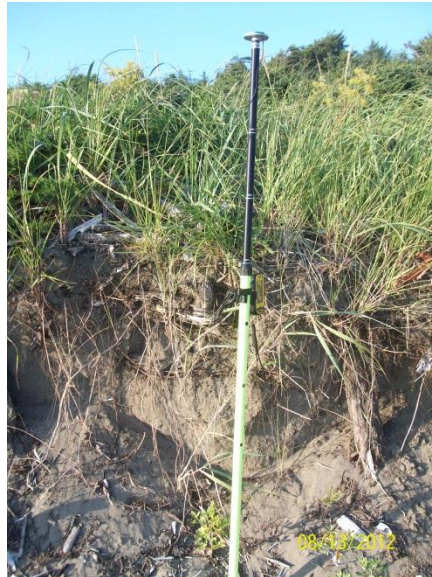
isostatic uplift zone. The accretion of sands within this area is seen with a drop of about 1 meter from the upland side to the shoreline elevation (Figure 18). The annual ebb and flow of sand deposition historically resulted in a net annual deposition of sands along this shoreline. Currently, the balance has turned to accretion as net sand accumulation reduces annually.

Figure 18 shows a photograph (August 2012) at the summer high tide mark along the marine shoreline slightly north of the mouth of the Moclips River. This area has lost about 1 meter of sand depth (vertical).

Figure 18. Avulsing CRLC sands north of the Moclips River along the Grenville Bay shorelines; staff is 2 meters tall, sand loss is about 1 meter in depth.

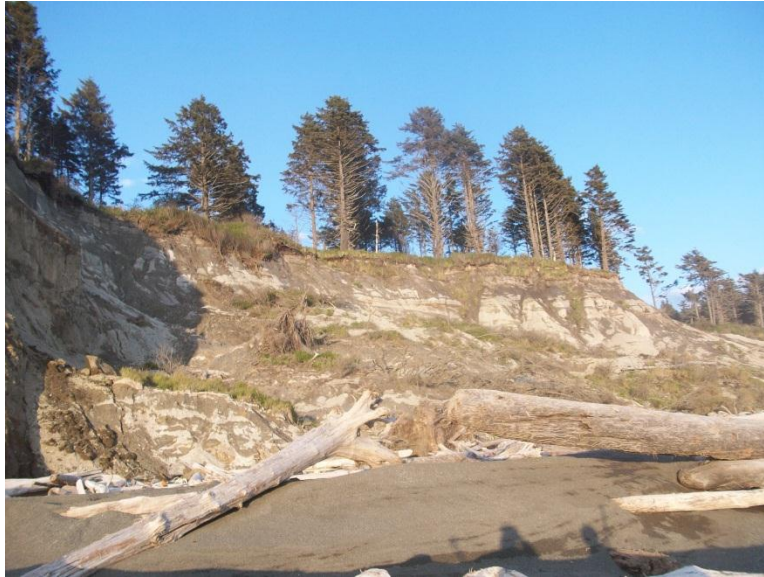
Point Grenville is a conspicuous promontory of basalt materials situated along the Quinault Marine Coastline. This location serves as a unique combination of geologic strata where several types of geological materials come together. Point Grenville marks the northern extent of the CRLC where fine sands blanket the coastline to the south (Figure 15). North of this point, the geologic bedrock materials give rise to the Quinault Formation where fine-grained rocks, such as massive siltstones, to coarse-grained beds of sandstone and conglomerate combine to create steep cliffs adjacent to the beach (Figure 22). This formation has failed in several places from Point Grenville northward, as the “Taholah Road” was built across this substrate then lost to wave-cut platform process shoreline erosion (Figure 23).

Figure 22. Quinault Formation rocks north of Point Grenville where once the Taholah Road was placed.

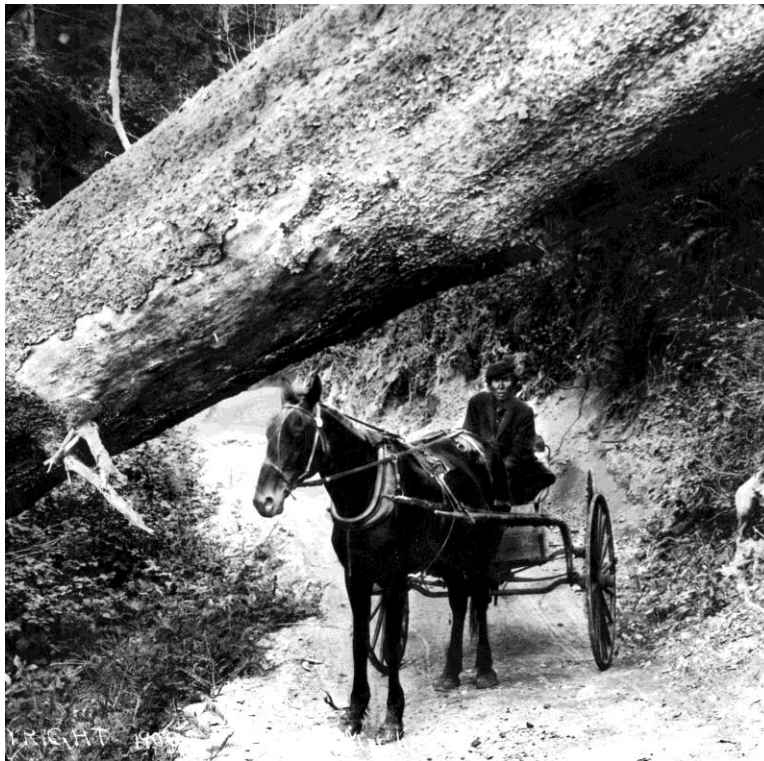
Figure 23. Point Grenville Cutacross Road 1906 (by O. S. MacKenzie (Workman 2012)).

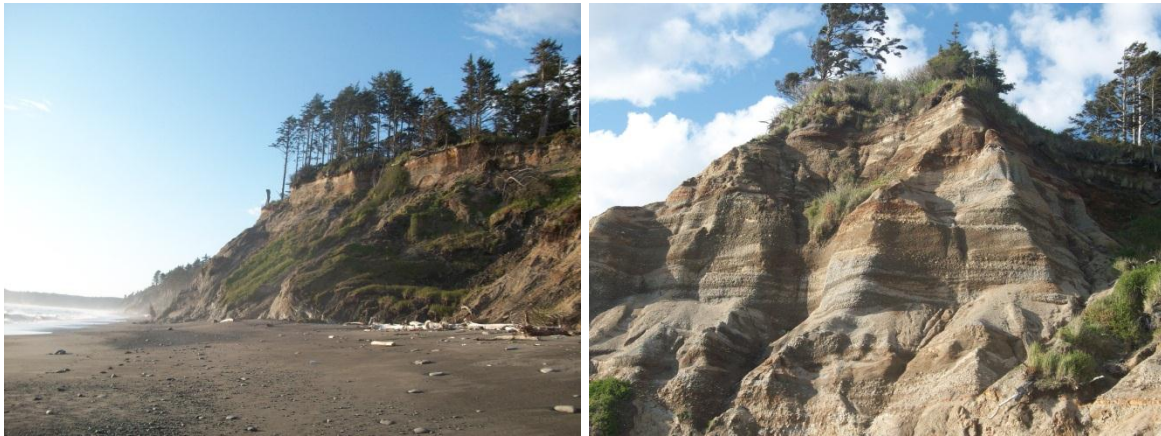
This reach begins north of Point Grenville and extends northward to the edge of the Lower Taholah village. This shoreline area is dominated by the Quinault Formation rock cliffs shaped by the wave-cut platform processes (Figure 29). As the Pliocene Epoch unfolded (1.5 to 7 million years ago), the Quinault Formation was formed in deep sea floor environments from consolidated, stratified, and then tilted sedimentary rocks. These sedimentary rocks are younger in geologic age than the Hoh Assemblage rocks and the basaltic remnants scattered under the Quinault Formation.

Figure 29. Quinault Formation cliffs located north of Point Grenville. Structural weakness of underlying massive siltstone of the Quinault Formation combined with the wave-cut platform process is part of the cause of landslides in this area.

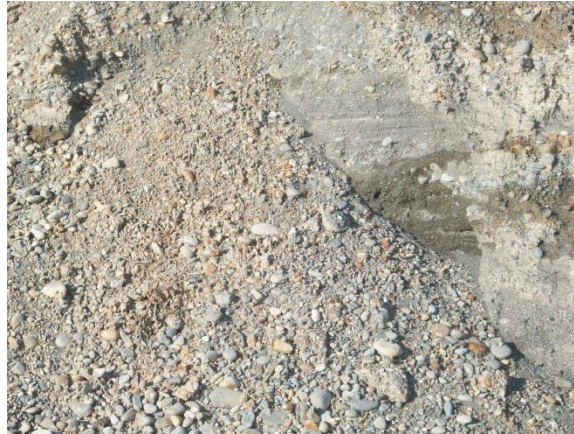
The features of young sandstone overtopped by the organic matter deposited since the last ice age contain gravels that are intermixed within these strata and ultimately accumulate along the base of the cliffs and along the shoreline (Figure 30). This alternation of materials (sand and gravel) leads to several places of “drunken forests” where trees along the cliff line become unstable, fall en masse, and are converted to local LWD along the shorelines.

Figure 30. Gravel accumulation along a Quinault Formation cliff base.

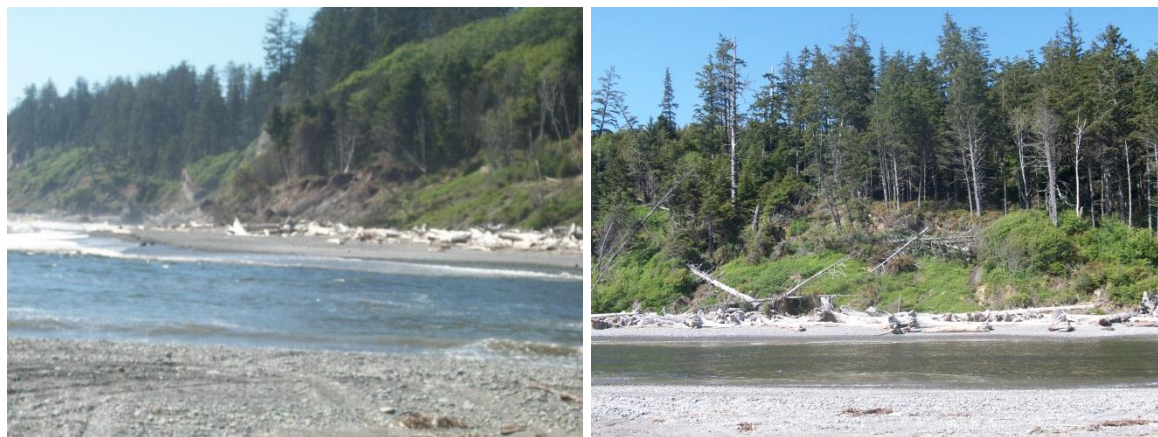
To the south of the Quinault River's entrance to the Pacific Ocean, and along the northern cliffs of the river's banks, the Quinault Formation dominates the substrate. Smaller inclusions of the Hoh Assemblage are identified along the northern banks. The Quinault Formation can be found in association with disruptions such as a perpendicular fault line separating the two discontinuities. The Quinault Formation materials of the northern Quinault River bank are characterized by mass wasting events such as landslides and slumps (Figure 34).

Figure 34. Slumping and wasting north of the Quinault River in Hoh Assemblage rocks.

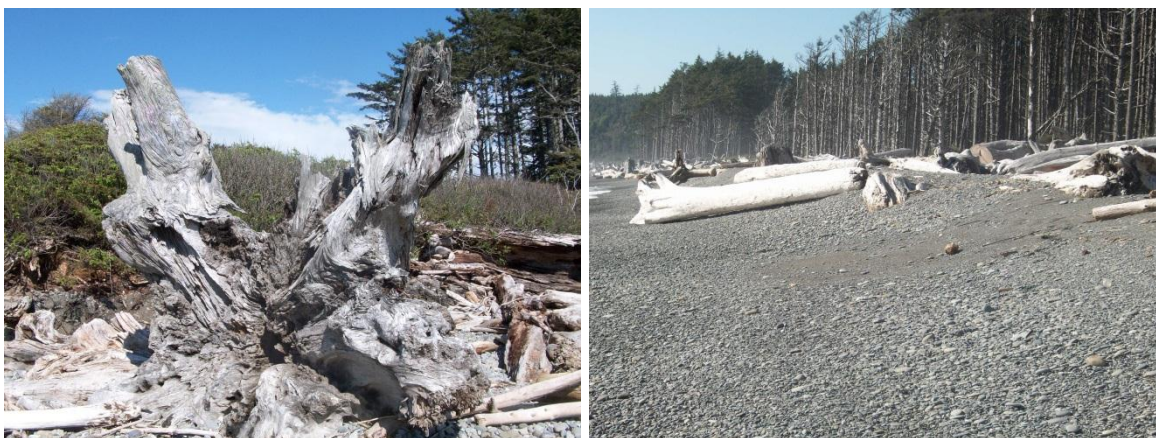
The LWD of this reach of the coastline is substantial as locally contributed logs with root wads are combined organically from the Quinault River, from marine shorelines adjacent to the reach, and combined with LWD from distant sources (Figure 37). These LWD materials provide a substantial avulsion limiting amenity to the local marine shorelines. The logs are not only present at the surface of the shorelines, but they are also embedded deep in the shorelines sands, silts, and conglomerates. Their presence here provides the village of Taholah with a level of stability against accelerated shoreline encroachment.

Figure 37. Large woody organic materials of the Taholah marine shorelines, and a steep shoreline approach to the upper limit of high tide.

A review of the right side photograph of Figure 37 gives the reader supporting evidence through the steep shoreline approach within the intertidal zone to the upper limit of high tide, identifying the terrain rise in this area. The terrain has lifted faster than sea level has increased, causing this steep intertidal shoreline angle.

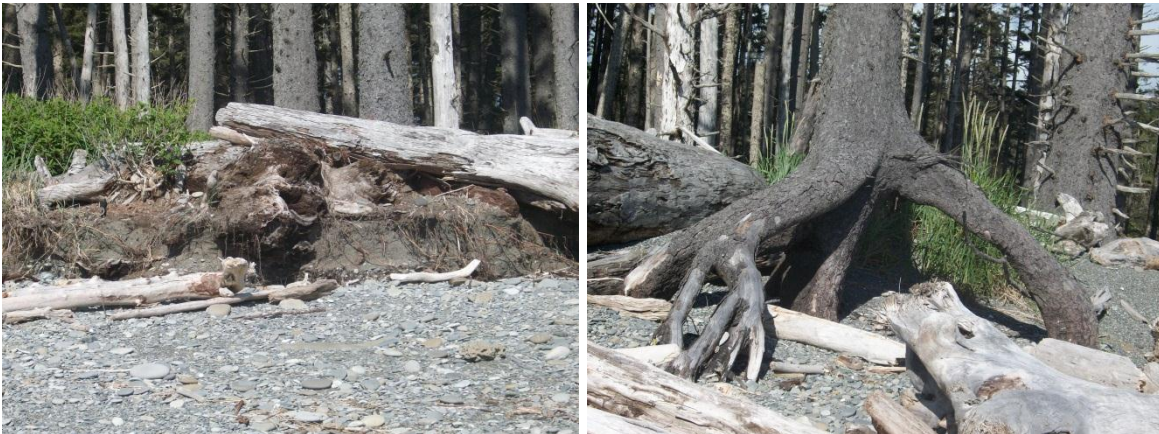
Several other facets of significance apply to the situation seen along the marine shorelines near Taholah. In combination with the large amount of LWD along these shorelines, there is active isostatic rebound exceeding sea level rise in this area nearest to Taholah (Figure 38). The sandy duff layer, shown on the left side of Figure 38, shows about 2 feet of uplift. The right side

of the images shows a Sitka spruce tree with the bottom 2 feet of the tap root exposed above the initial base of the tree at the time of germination. The progression of this uplift was slow enough to allow the tree to continue its growth, year to year, while adding a bark layer to the tap root (a feature not normally covered with bark). By 2012, this tree senesced and will be contributed to the LWD of this shoreline in the near future.

Figure 38. Shoreline slope, uplift of the land, and LWD combine within this reach.

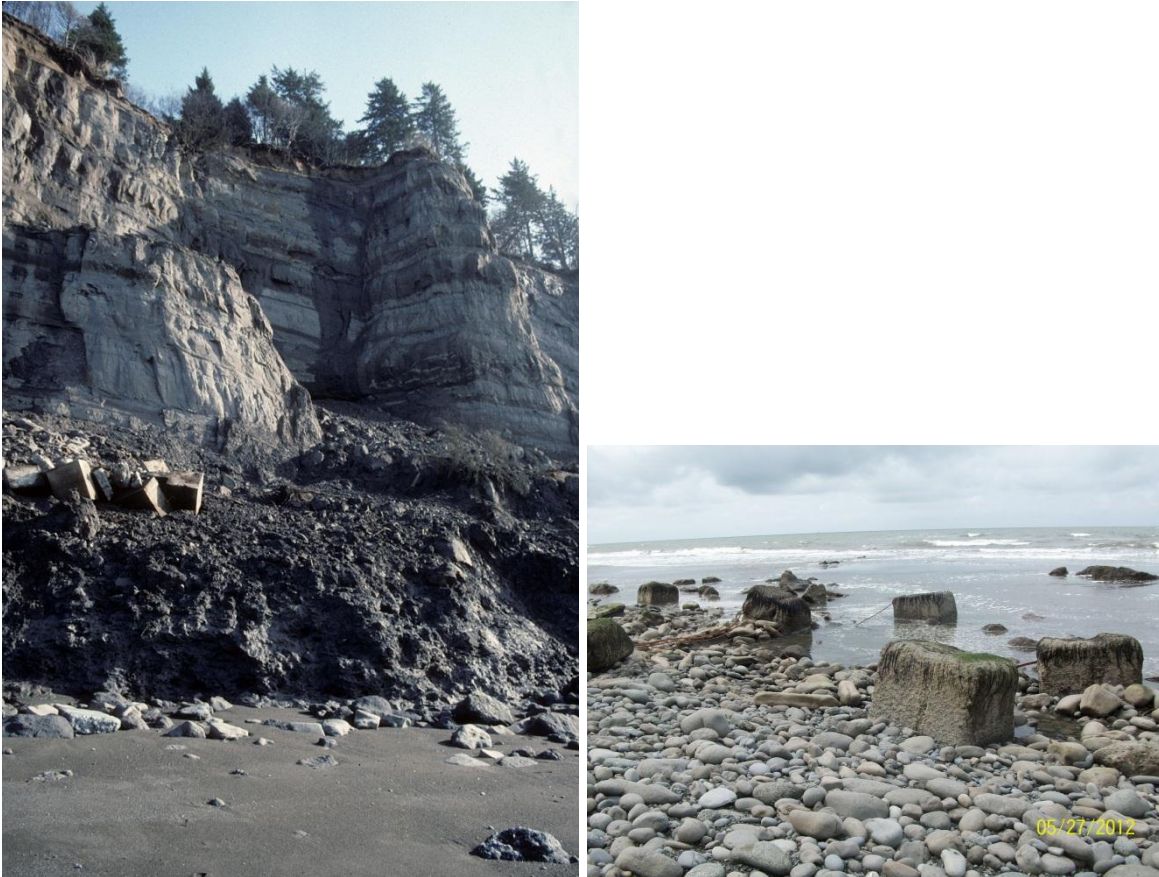
This erosion of the Quinault Formation rocks has continued into 2012 as the cliff materials adjust for equilibrium. In February 1993, QIN staff member, Larry Workman, photographed concrete foundation blocks from the bunker site that were being shepherded down the cliff (Figure 41). In May 2012, Kamiak Ridge investigators, William Schlosser and Dan Lawson, photographed the same concrete blocks, with rebar still attached, sitting in the intertidal zone at sea level (Figure 41).

It is important to recognize that the blocks photographed in 1993 and 2012 most likely did not change their horizontal position appreciably during those nearly 20 years. The change is seen from an erosion of Quinault Formation debris at the base of the eroding cliff face in response to the disturbances caused by the bunker's construction. The foundation blocks only settled to sea level as finer materials were washed away by wave-cut action.

Figure 41. Concrete foundations from the WWII Artillery Bunker Site north of Cape Elizabeth, avulsed to the ocean shorelines from 210' above. Left photograph February 1993 (Workman 2012), right photograph May 2012.

The vegetated cliff crest has horizontally avulsed over 400' as a result of the disturbances on the top of the cliff. A study of the scenes in the referenced PDF is summarized on page 5 of this set to combine all of the crest lines by reference year. It is clearly demonstrated that disturbances, such as the erection of a structure, accessed by a road, can lead to substantial failure on Quinault Formation rocks when combined with wave-cut platform avulsion.

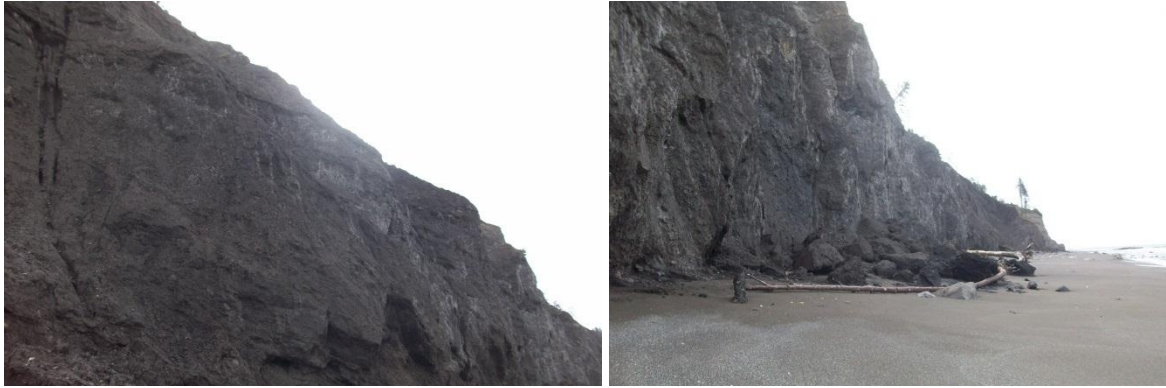
The Duck Creek Diapir is located at the northern part of this reach (Figure 42). The materials of the diapir show combinations of magma, sand, silt, deep-sea muds, boulders, rocks, and organic materials. As these formations avulse, the residual materials are a combination of sandy beaches, with remnant boulders scattered at the cliff base.

Figure 42. Duck Creek Diapir.

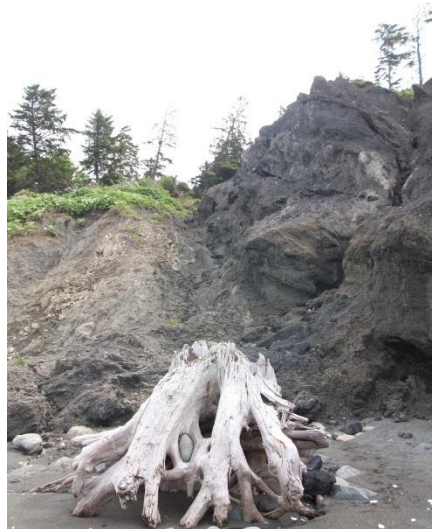
This reach has two intersecting fault lines that are located on each side of the Duck Creek Diapir (north and south) (Figure 43). The intersection of these faults is seen offshore of the coastline several hundred feet, but both faults extend inland considerable distances. These are considered active faults. Other strike-dip beds have been located along this reach giving evidence of the highly fractured formations of this area. This fracturing comes from both vertical and horizontal pressures.

Figure 43. Fault line separating the northern edge of the Duck Creek Diapir (right) and the Quinault Formation (left).

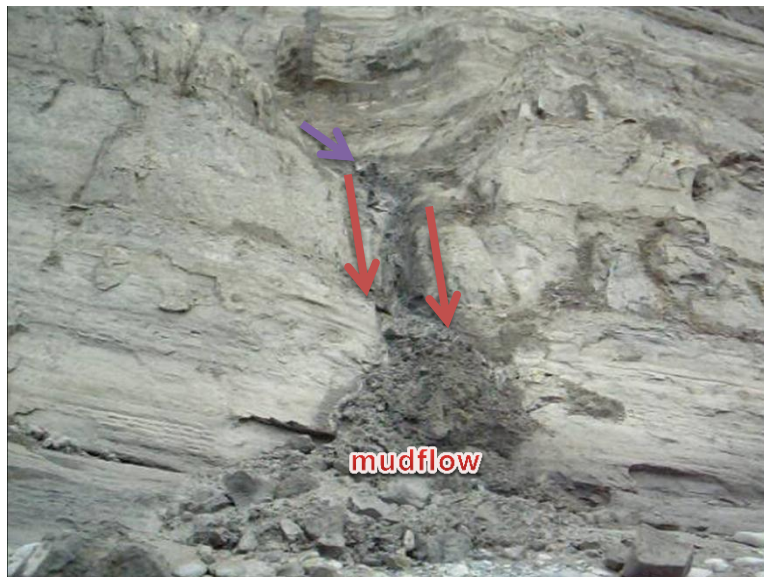
This reach of the shorelines is represented mainly by groups B and D. Group B soils are capable of moderate infiltration rates even when saturated. Group D has a slower infiltration rate, especially at saturation. The group D soils also contribute to cliff-face failures often seen within the Quinault Formation. This combination results in subsurface water flows from sites dominated by Group B, which transition to the Group D sites causing inter-structure evacuations of mudflows (Figure 44). The event witnessed in Figure 44 (May 2012) was seen as pulsating surges of water excised through the cliff's soils in the form of a mudflow. The mudflow was not a surface water conveyance, but instead was a subsurface evacuation of water and mud through fractures within the formation.

Figure 44. Quinault Formation mudflow within Hydrologic Soil group D, where subsurface water flow from Hydrologic Soil Group B transitioned into the saturated Group D soils. At the time of this event, no precipitation had fallen over 2 weeks.

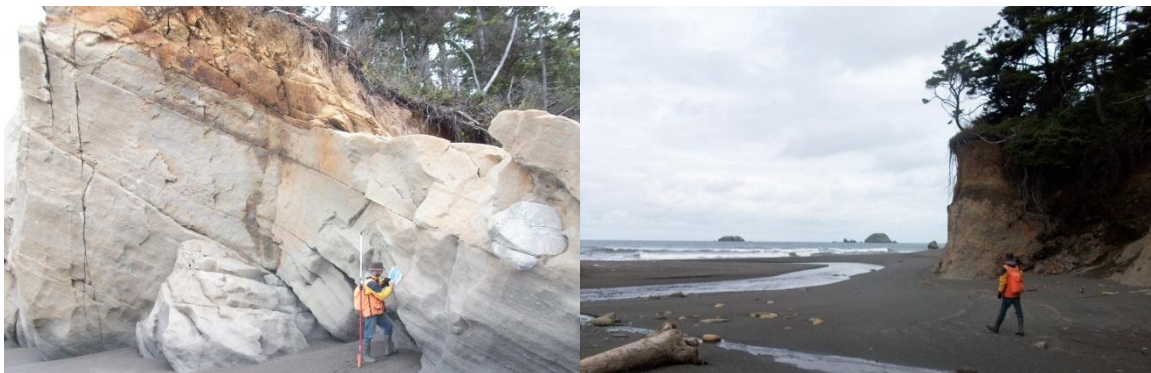
This reach begins at the northern side of the Duck Creek Diapir geologic structure and extends to Camp Creek. This shoreline area is dominated by the Quinault Formation rock structures (Figure 45). The elevation of the cliff edge crest is approximately 100-120', with several sea-level approaches for the rivers. The shorelines hold a gradual approach to the upper-limit of the intertidal zone and are dominated by sandy beaches. Isostatic uplift in this reach is evident and for the recent period, exceeds RSLC.

Figure 45. Quinault Formation sandstones being tilted and avulsed by wave-cut platform actions.

reach, especially where the Quinault Formation structures are tilted, compressed, and uplifted through tectonic pressures (Figure 45).

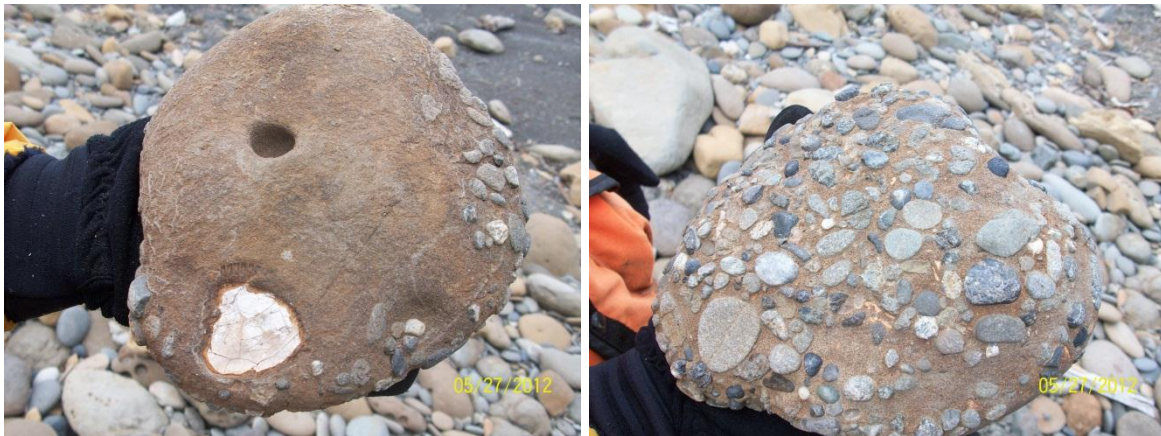
and transported up-watershed materials downstream. In many of the greywacke sandstones seen along the coast, angular fragments of various sizes of dark-gray siltstone occur in a variable-colored sand matrix (Figure 46).

Figure 46. Sandstone cobble with fossilized clam shell (left) and greywacke sandstone (right).

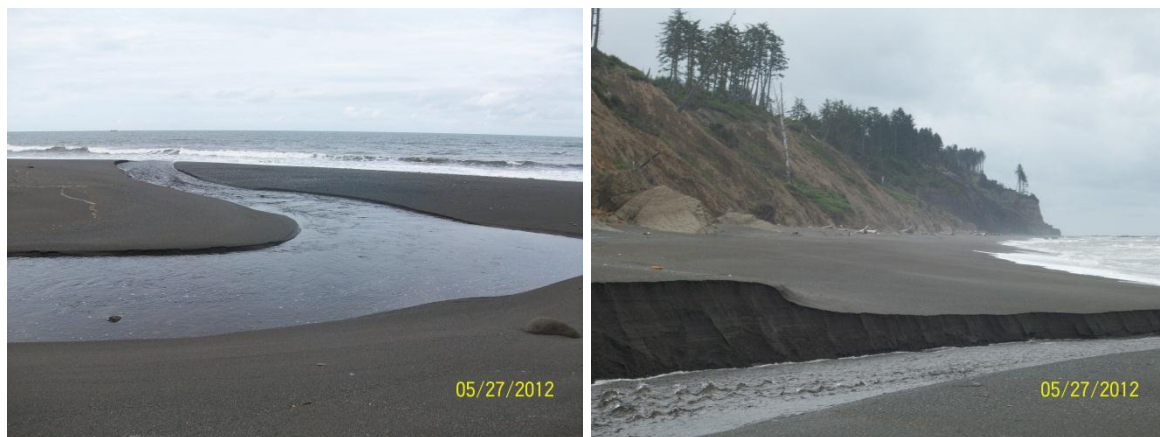
Figure 47. Camp Creek (left) and Duck Creek (right) pour points into the Pacific Ocean.

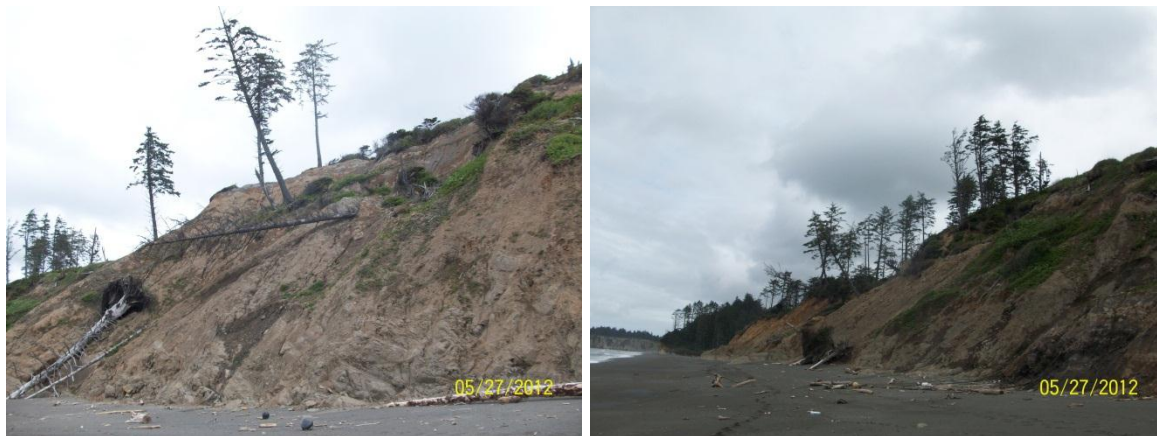
As with the previous reach (Cape Elizabeth to Duck Creek Diapir), this reach of the shorelines is represented mainly by groups B and D. Group B soils are capable of moderate infiltration rates even when saturated. Group D has a slower infiltration rate, especially at saturation. The group D soils also contribute to cliff-face failures often seen within the Quinault Formation. This combination results in subsurface water flows from sites dominated by Group B, which transition to the Group D sites causing inter-structure evacuations and wasting events (Figure 48).

Figure 48. Drunken forests and avulsing wave-cut platform cliff faces in response to destabilized soils near Duck Creek.

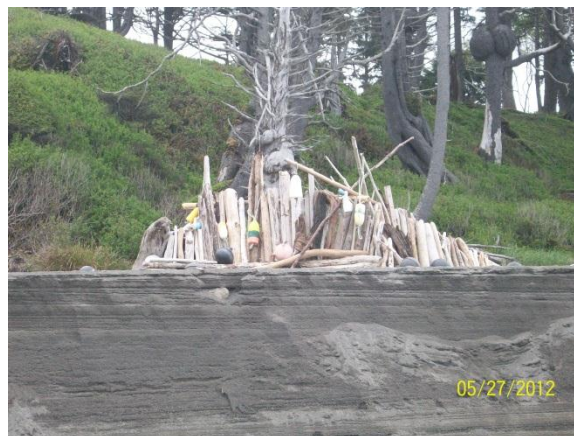
The Quinault Formation materials within this reach have been moderately uplifted since the last glacial period by a combination of forces including the expatriation of Olympic Mountain glaciers leading to isostatic uplift. Incidental disturbances from road building and timber harvesting along this reach has resulted in localized site failures and wave-cut avulsion, especially where the terrain attained higher elevations (near 100' or more). The silt dominated beaches surrounding the entry of the creeks to the ocean are fragile. The lack of heavy LWD along this reach is noticeable and facilitates shoreline erosion from high energy ocean waves (Figure 49).

Figure 49. Recreational uses near Duck Creek (recognize the silt dominated layers of the creek's terminal approach to the ocean).

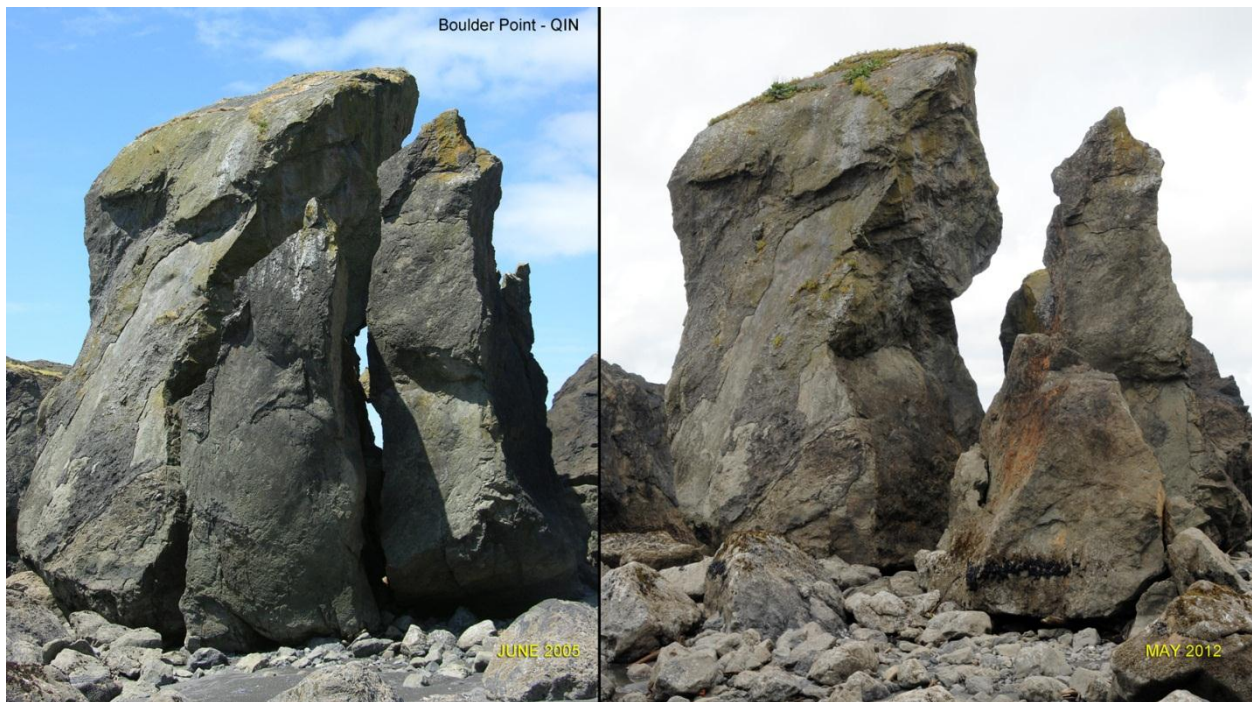
This reach begins at the southern side of the Pratt Cliff and extends to the north side of Boulder Point. This reach spans the bedrock materials of both the Quinault Formation (southern) to the Hoh Assemblage rocks (northern). The transition is clearly evident as the viewer traverses this reach. To the south, near Pratt Cliff, the shorelines are sandy and smooth, with a gentle approach from the seaward side, covered by sandstone boulders expatriated from the cliff faces. To the north, boulders cover the beaches near the cliff lines, aptly giving the name for Boulder Point (Figure 50).

Figure 50. Boulder Point rock structures in 2005 (left) and 2012 (right) (Workman 2012).

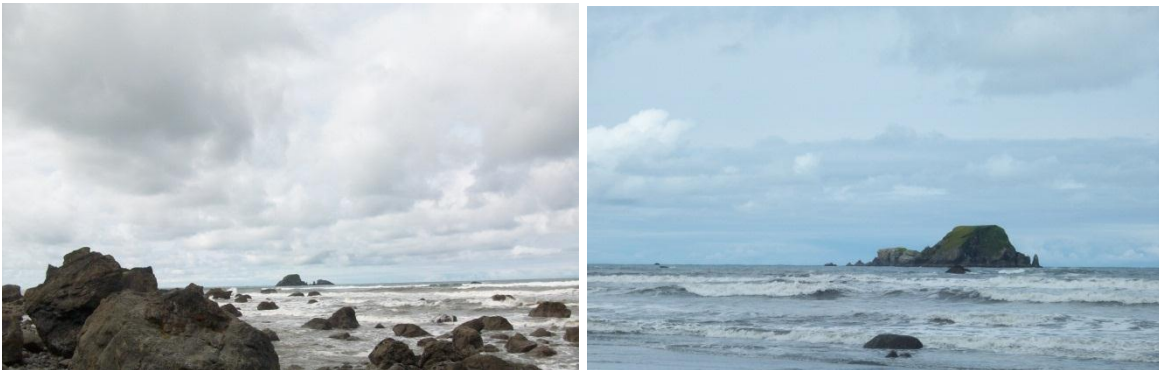
As has been observed in other reaches along the QIR marine shoreline, an active fault line separates the transition between the two bedrock formations. The fault line cuts across offshore lands and onto the terrain at about 45° azimuth. Offshore of this reach are located the Split Rock and Willoughby Rock islands (Figure 51).

Figure 51. Split Rock (left), Willoughby Rock (right).

Rau (1973), using land survey findings from 1902 to 1973, concluded that shoreline erosion is proceeding at a rate of about 375 feet per century in this reach. Based on that rate of change, he concluded that Willoughby Rock (Figure 51) was likely the western edge of the mainland about 1,200 years ago.

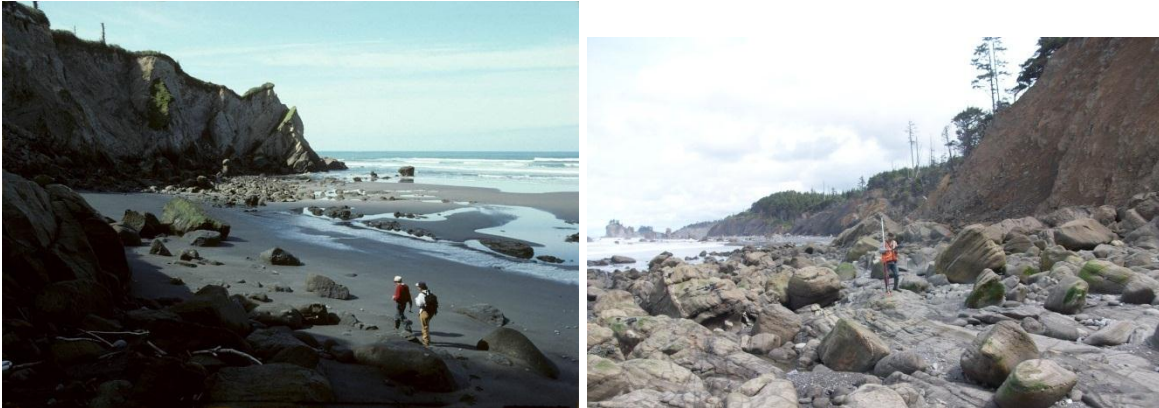
The southern shoreline (Pratt Cliff area) of this reach is dominated by the Quinault Formation rock structures (Figure 52). These sandstone and siltstone formations are highly tilted and irregularly broken, leading to boulders distributed along the base of the cliffs and within the intertidal zone. These cliffs are not as uplifted as the Quinault Formation rocks of Cape Elizabeth, with only about 100 feet of apparent uplift from shoreline to cliff crest. Tree trunks and other LWD are not abundant in on this reach. As the cliff faces have been disturbed, several rock falls have resulted and remain at the base of the cliff.

Figure 52. Pratt cliff from the north, looking south (Workman 2012) (left). Sandstone boulders liberated from the Quinault Formation cliffs north of Pratt Cliff (right).

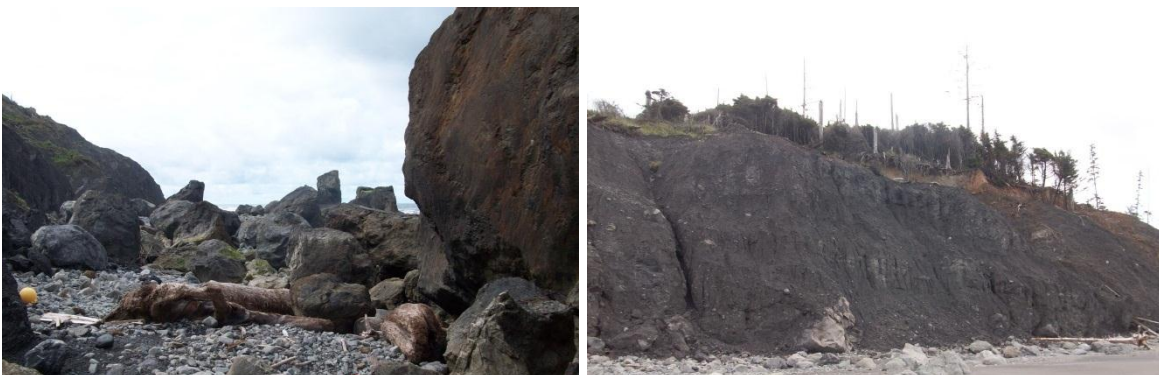
As the viewer progresses in the direction of Boulder Point, the bedrock formations transition to the Hoh Assemblage. Within this assemblage, several piercement formation structures are seen. These diapir structures represent a conglomeration of sands, silts, basalt remnants, and carbonized organic matter. Within the intertidal zone near Boulder Point, a release outlet of methane gas was observed. The recruitment of these materials from wave-cut action and to the shoreline is substantial (Figure 53).

Figure 53. Hoh Assemblage structures with diapir arrangements are common near Boulder Point.

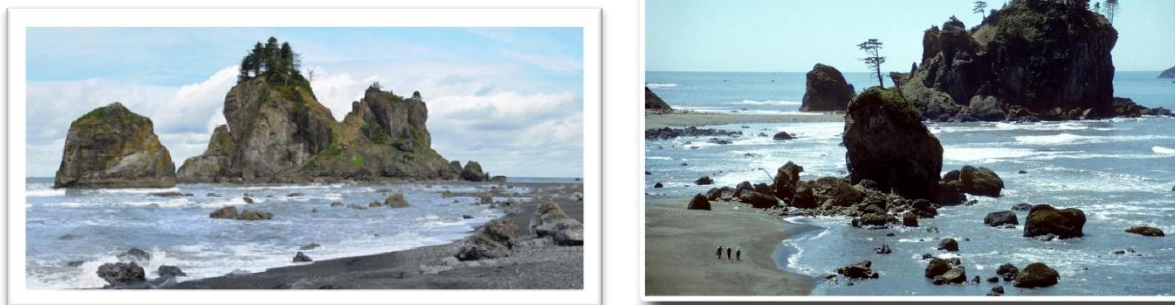
This reach includes both Hogsback and Little Hogsback nearshore structures (Figure 54). This reach from Boulder Point through the Hogsbacks area spans the bedrock materials of the Hoh Assemblage rocks. The cliff crest along this reach attains between 100 and 120 feet, except where cut by streams. The shoreline is mainly overlaid with boulders that originated in the cliffs of the Hoh Assemblage, including the diapir formations. These rocks are a chaotic assemblage of siltstone, sandstone, conglomerate, and volcanic material.

Figure 54. Little Hogsback (left) and Hogsback (right) (Workman 2012).

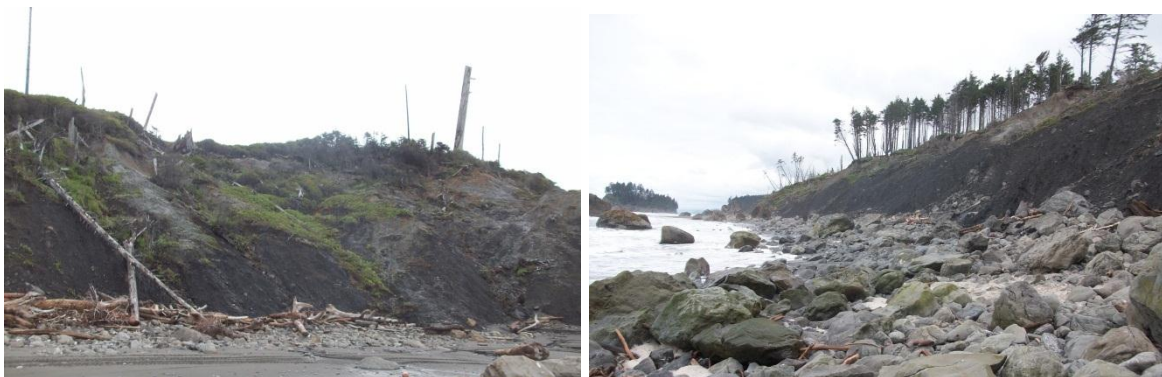
The Cape Elizabeth road (originally from near Queets to the Cape) once continuously paralleled this shoreline providing access on a single track dirt road. Access across Whale Creek and Raft River (to the north) washed out some time between 1955 and 1977 significantly reducing traffic along this path. Currently, access using this road is possible from Taholah as far as Raft River. Other secondary access roads link this stretch of the road to other access points. The formidable cliffs seen along the Quinault Formation bedrock structures are not seen in this reach. The cliffs are sloped and ridge top vegetation is recruited to the shoreline as locally recruited LWD and boulders from within the formation (Figure 55).

Figure 55. Recruitment of LWD and boulders to the shorelines.

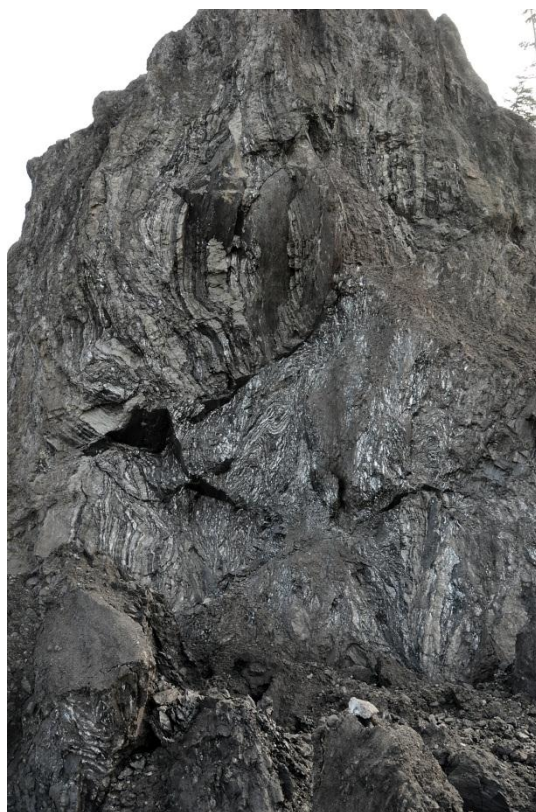
Both Hogsback structures originated from the shoreline formations but have been eroded by wave-cut platform patterns to create these islands, separate from the mainland. The erosional remnants contain conglomerates, stratified sandstone and siltstone, and volcanic materials (basalt) (Figure 56). The process of separation from the mainland is ongoing, but it is concluded that the separation of the Hogsbacks from the mainland has happened within the past 2 centuries (Rau 1973). The basaltic core of these structures remained in place after the fine grained materials of the tectonic *mélange* were eroded away by the sea. The outcrops of Little Hogsback and Hogsback (Figure 54), and the offshore rocks of Split Rock and Willoughby Rock (Figure 51), are all volcanic in origin and are erosion resistant blocks. These features were once incorporated in the *mélange* but now are erosional remnants enduring along the coast.

Figure 56. Extremely distorted rocks of the tectonic mélangé, showing a chaotic mixture of compressed soft silt and clay (Workman 2012).

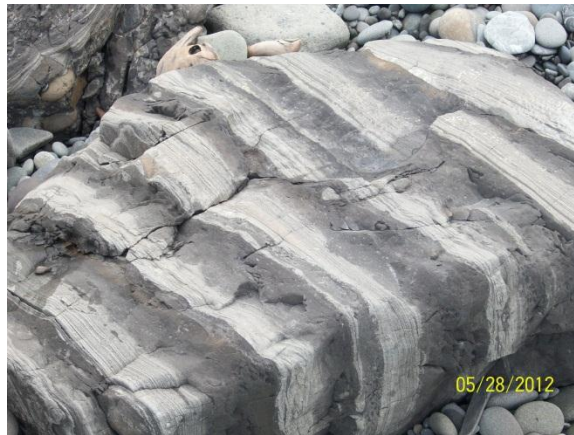
The Hogsbacks area has many volcanic fragments, mixed with fragments of siltstone and other sedimentary rock types (Figure 57).

Figure 57. Stratified sandstone and siltstone sediment structures formed in a nearly horizontal position as sediments millions of years ago, have been turned, broken, and eventually are incorporated into the shoreline or held in the formation's cliffs.

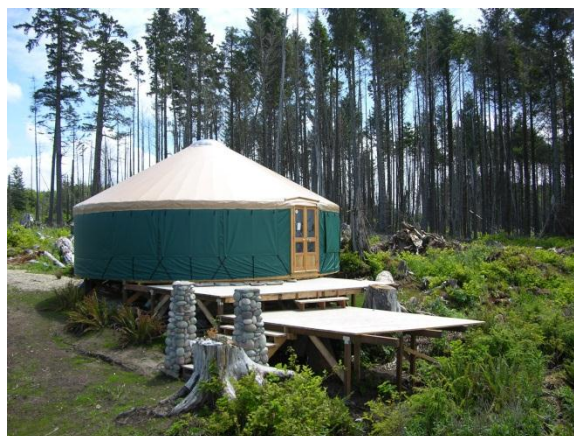
During site visits to this reach, a collection of parcels in Section 28, Township 23 N Range 13 W, held in Fee status, was visited to view a site where timber was substantially harvested at some time before 2000 and later a camping site was developed (Figure 58 & Figure 59). Several references in this document have been made about the instability of developing structures near the cliff face edges of Hoh Assemblage and Quinault Formation bedrock materials. This property combined substantial timber harvesting with road building and low impact site developments.

Figure 58. Yurt tent site erected near the cliff edge northeast of Hogsback in 2005 (Workman 2012).

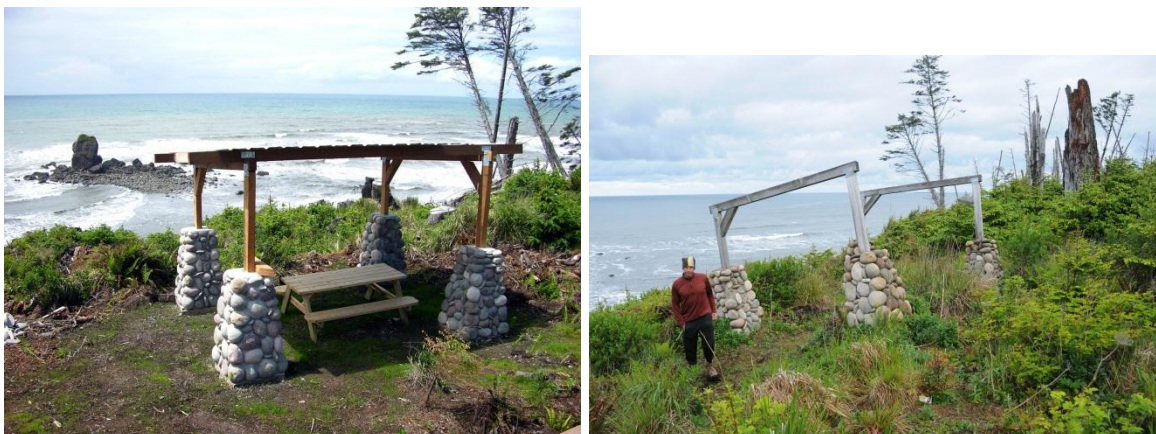
The compromise of the cliff edge is seen in Figure 59, where the picnic table protective roof frame in 2005 was fully erect, but in 2012 was already partially compromised by cliff face avulsion. The failure at the crest of the cliff was a response to wave-cut platform erosion at the base of the cliff and the release of the cliff face in response. The bedrock of this area is mainly piercement structure materials.

Figure 59. Picnic table enclosure located along the Hoh Assemblage rock cliff edge in 2005 (left) and 2012 (right) (Workman 2012).

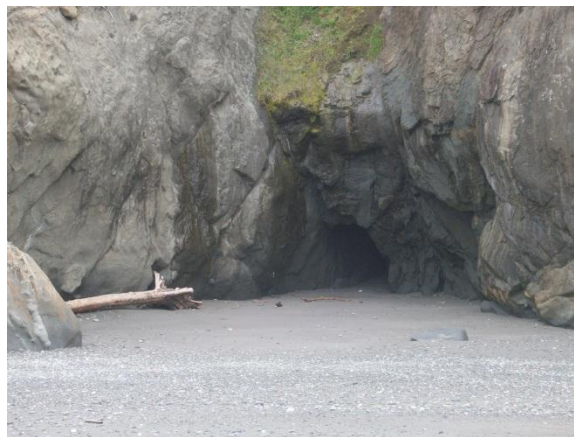
Cliffs of this entire reach attain a height of between 100 and 120 feet and form cliffs that are sheer faces along the Quinault Formation bedrock, and rounded, slumping cliff crests on the Hoh Assemblage and tectonic breccia bedrocks. Wave-cut platform structures creating near sheer cliff faces are seen along the Quinault Formation bedrock materials location north of Raft River (Figure 63). Within the Hoh Assemblage and the composite material hills adjacent to the shoreline, the shape is not as pronounced and results in lower cliff tops and slumping to the shoreline.

Figure 63. Wave-cut platform characteristics against a Quinault Formation cliff north of Raft River.

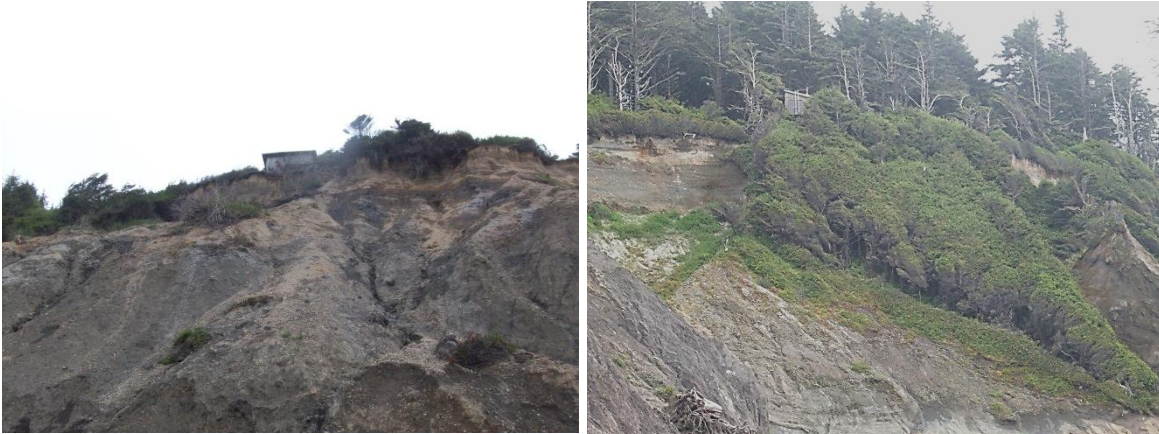
Near the northern extent of this reach, in section 21, a couple Fee owner recreational structures have been erected. One of these is located a near the cliff edge (Figure 64). It is probable that the process of the wave-cut platform avulsion of the cliff faces has diminished the distance from cliff edge to structure over time. It is also likely that this structure (and others like it) will be compromised as the cliff faces avulse and fall to the shoreline.

Figure 64. Private recreational cabins and out buildings, north of Raft River, also seen on map book page 31 (left) and page 29 (right).

During site visits to this reach, a collection of parcels in Section 21, Township 23 N Range 13 W, held in Fee status, was visited to view structures that appear to be located close to the cliff face and at risk of falling as the cliff avulses. This situation is documented in Figure 64. On this particular site, the bedrock materials are of the Quinault Formation, but those have been overtopped by glacial outwash composite materials.

These inter-structure moisture evacuations are more probable in the Quinault Formation bedrocks, especially where gravelly outwash resides on top of the bedrock formations (ex., Figure 64). When moisture accumulates on the gravelly materials, near the top of the cliff face, water is quickly transitioned to lower and moisture-flow resistant soil layers. As the fluids intercept the Group D class soils, ruptures in the cliff face structure can be seen as rapid avulsions and cliff face failure.
