QUINAULT
INDIAN
NATION

REACH ASSESSMENT DESCRIPTIONS

Quinault Indian Reservation Reach Assessments | William E. Schlosser

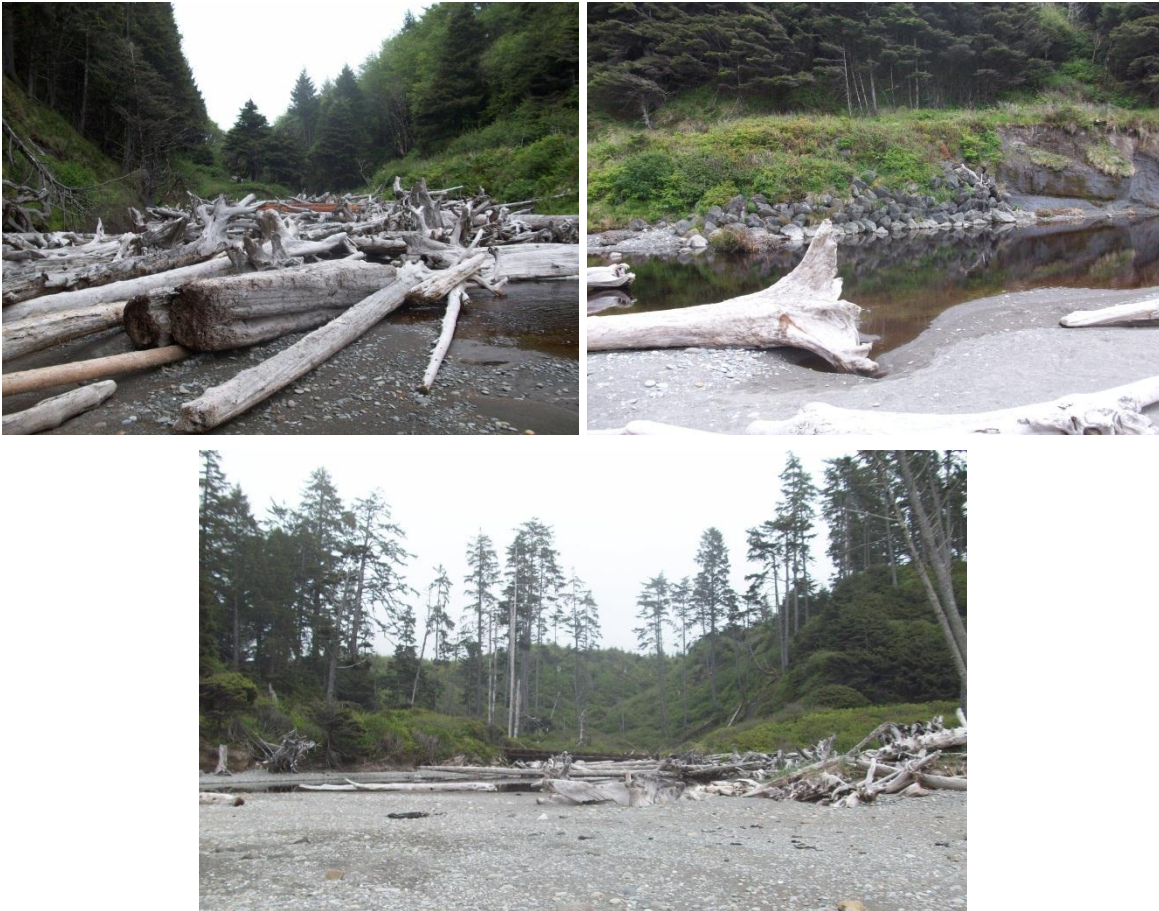
Whale Creek enters the ocean shoreline as two forks aptly named “North Fork” and “South Fork”. By 1939, the Cape Elizabeth Road extended from near Queets to Cape Elizabeth, with crossings of both forks of Whale Creek. The path in the road was given a jog as it approached the forks to descend to near sea level. This descent was accomplished by placing rip-rap on the ocean side of the road between the forks to stabilize it against sea-side erosion. The road’s bridge crossings were compromised on both forks, LWD accumulations in the channels became considerable, and the road between the forks became impassable (Figure 65). Today the North Fork Whale Creek is plugged by LWD logs in the stream channel.

Figure 65. North Fork Whale Creek (left) notice bridge remnants upstream colored red, and rip-rap placed along the road bank between the Whale Creek forks (right), and the South Fork Whale Creek bridge (lower).

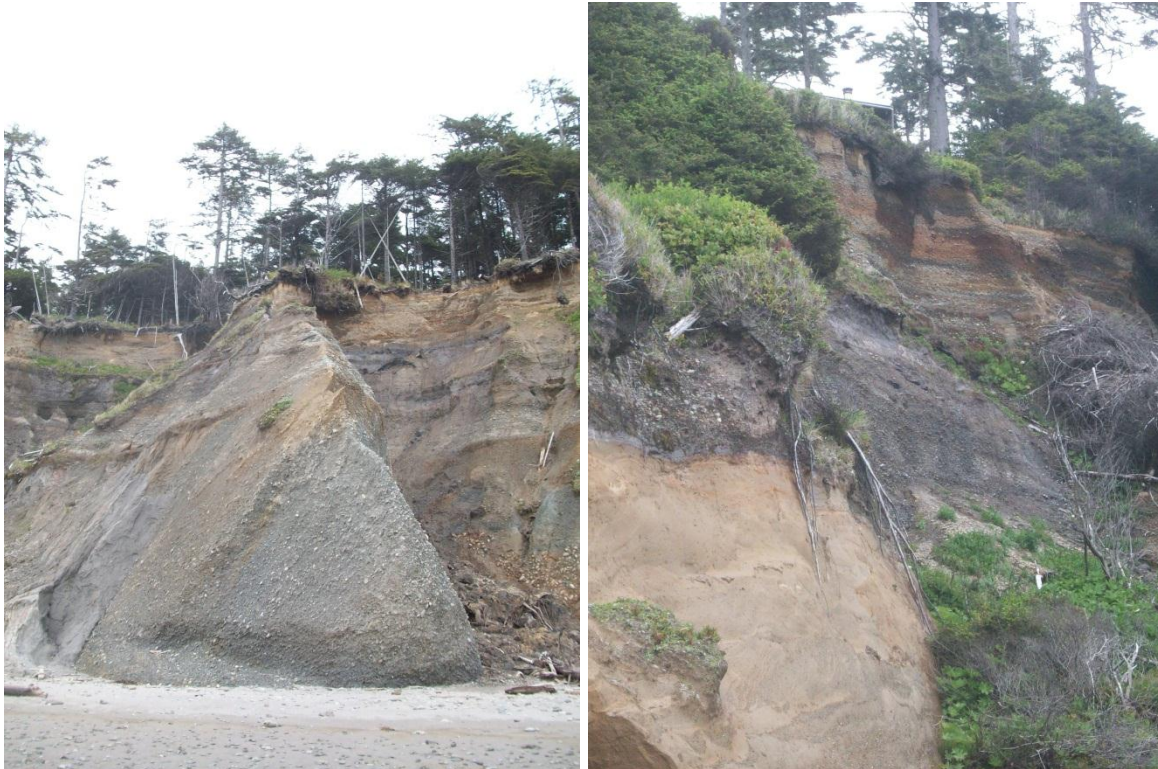
Sand and gravel cliff faces are common surrounding Whale Creek. The materials here are mainly Pleistocene sedimentary materials accumulated within the Olympic Mountains and were transported to their present location by glaciers and streams from the glaciers during two different periods of time in the Pleistocene Epoch (within the last million to million and a half years). Upper layers were deposited around 17 and 70 thousand years ago during the last glacial period (Figure 66).

Figure 66. Sand and gravel cliff faces common in the cliffs surrounding Whale Creek.

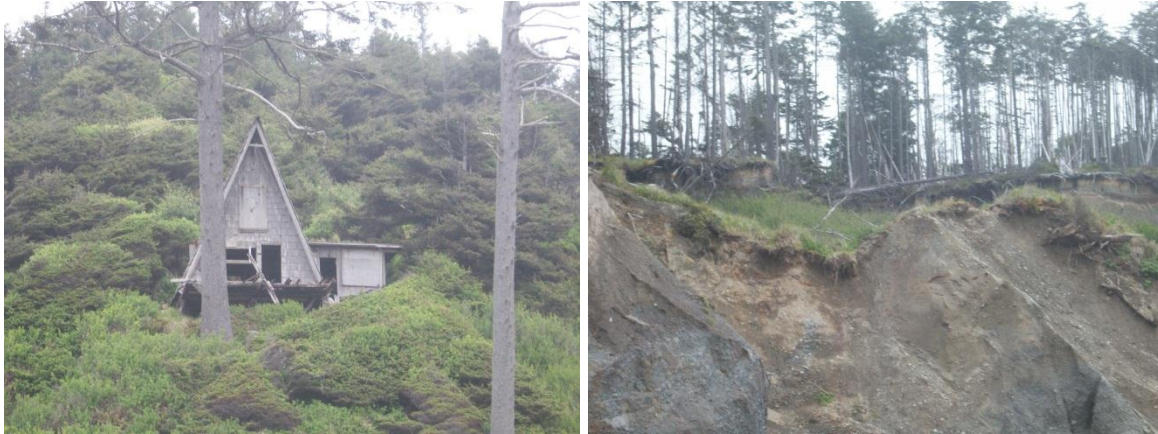
Across this reach, recreational cabins have been erected with connecting roads. Most of the access comes from the Cape Elizabeth Road with access near Queets along Highway 101. These cabins and cottages are often placed in close proximity to cliff edges where evolution is likely. Several structures have already been compromised as they fall to the shoreline. Other structures are literally “at the edge” of falling to their demise (Figure 66, Figure 67, 0).

Figure 67. Recreational cabin placed within the avulsing cliff face (left) and slumping Sand and gravel cliff face (right).

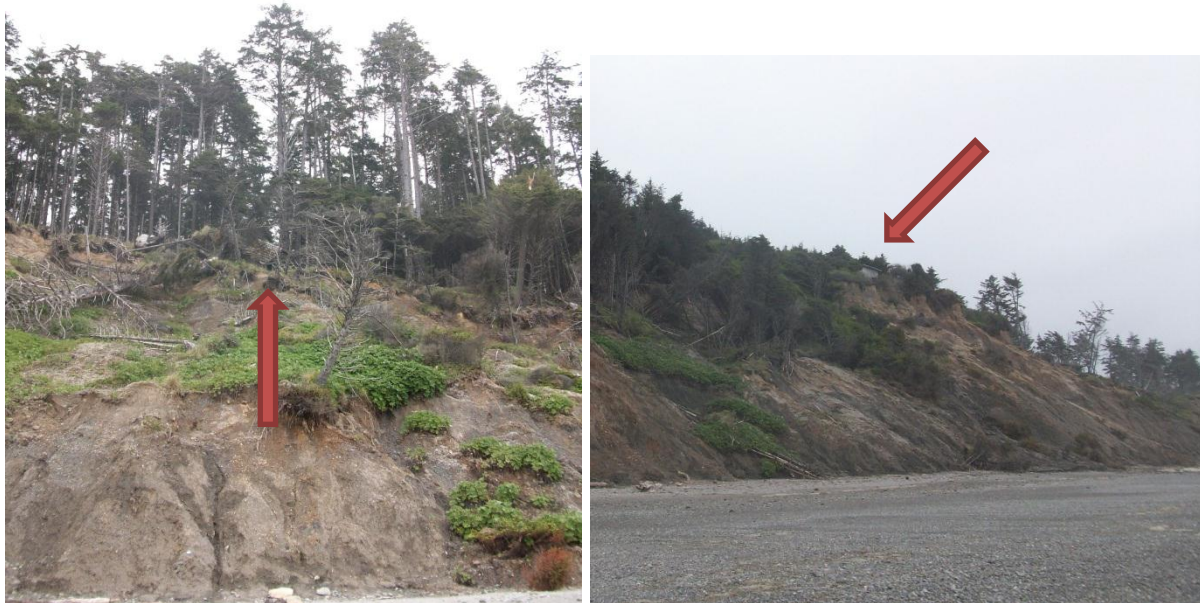
The cliff face bases are covered with scattered LWD deposits. Most of those deposits are locally derived tree stems from the avulsing cliff faces. Drunken forests are common along this reach, owing to the low structural integrity of the cliff face materials (sands and conglomerates).

Figure 68. Cliff crest avulsion along the sand and conglomerate cliff tops near Whale Creek that have compromised a cabin (left) and threaten a structure at the crest.

Because of the structurally incoherent characteristics of these materials, site developments, road building, and even timber harvesting should be extremely limited in this reach. These materials are prone to failure when disturbed. The set-back recommended for the Hoh Assemblage and Quinault Formation bedrock materials may be modified to include 3 times the height of the shoreline cliff crest, or 500 feet from the cliff crest, whichever is greater. This extends the "set-back" from 2 times the cliff crest height, to 3 times, in order to limit the disruptions to the cliff faces from disturbances.

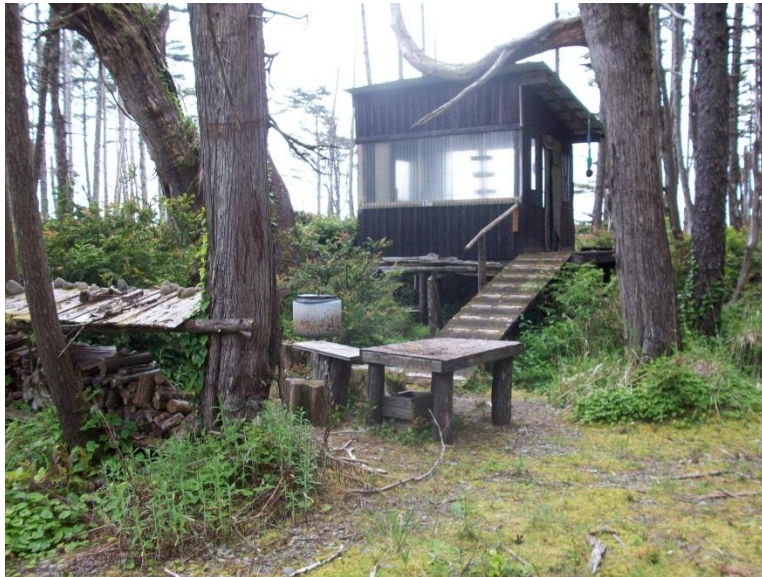
Fee parcels within this reach have erected recreational structures at the top of the cliff faces. Some have an extended set-back from the cliff edge. This set-back is beneficial to the stability of the cliff structure (Figure 69). Other edifices were erected close to the cliff faces, or with parking areas located very near the cliff edge. Where these are located, cliff crest failure has followed (ex., page 28 of oblique views).

Figure 69. Fee parcel with a significant cabin set-back from the cliff edge, limiting site disruptions.
